Road Safety Audit of the Third Ring Road (Highway) in Benghazi City, Libya

Traffic accidents represent one of the most significant global challenges, causing substantial human and economic losses. This study focuses on analyzing traffic accidents in Benghazi, Libya, which has experienced a steady rise in accident rates. According to 2023 statistical data, Benghazi recorded 1,524 accidents, resulting in 178 fatalities, 518 major injuries, and 539 minor injuries. A temporal analysis from 2014 to 2023 reveals a significant upward trend in accidents and injuries. The study also conducts a detailed road safety audit of the vital Third Ring Road in Benghazi. The methodology involved repeated field visits, visual inspections, and documentation using standard audit forms and photography. The audit results identified critical safety issues stemming from a combination of engineering deficiencies and risky driver behaviors. Key problems include a lack of traffic signs, neglected pedestrian infrastructure (including subways), poor road surface conditions, damaged safety barriers, and inadequate road markings. The study concludes with practical recommendations to improve safety conditions on t

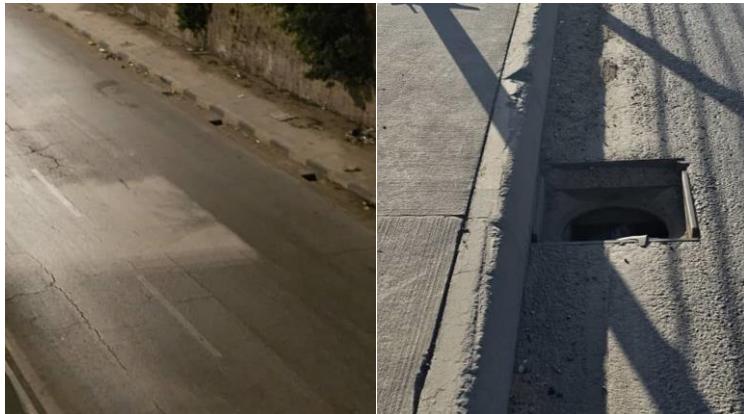
Figure (2): Uncovered Stormwater Drain Openings

Most drain openings along the study route were observed to be uncovered, posing a hazard to vehicles and pedestrians. The absence of covers can negatively affect driver safety and increase the likelihood of accidents as drivers attempt to avoid them. It also causes tire and wheel damage, potentially leading to vehicle breakdowns or loss of control.

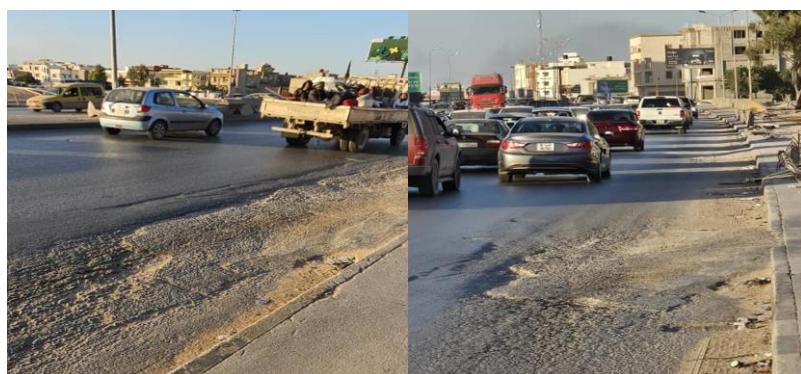
Figure (3): Road Surface Defects

The presence of defects like potholes and cracks negatively impacts road user safety. They cause sudden reactions from drivers trying to avoid them, potentially leading to loss of control. These defects also damage vehicles and tires and can contribute to water pooling during rain, increasing skidding risks.

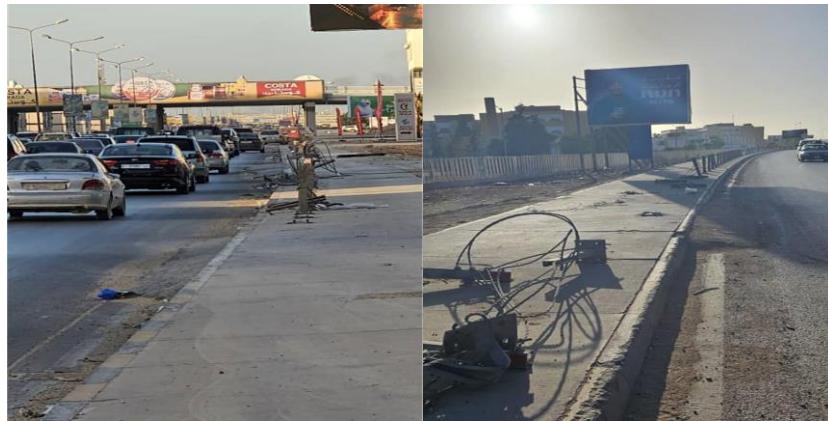
Figure (4): Damaged Safety Barriers

Safety barriers on road sides play a vital role in enhancing safety. If missing or damaged, they lose their ability to redirect vehicles and keep them within the roadway, increasing the probability of vehicles hitting solid objects or overturning.

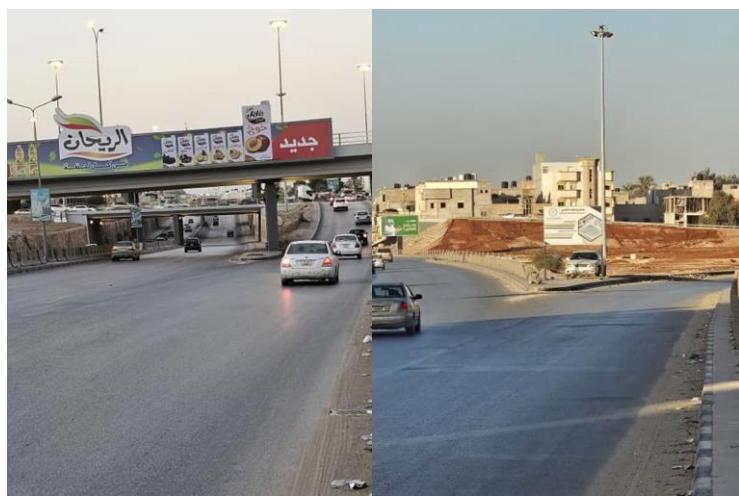
Figure (5): Lack of Road Markings

The absence of clear and well-maintained road markings, such as lane dividers, direction arrows, and exit gore markings, negatively affects safety. It makes it difficult for drivers to maintain their lane and identify exits, leading to sudden lane changes, disruptions in traffic flow, and increased rear-end collision risk.

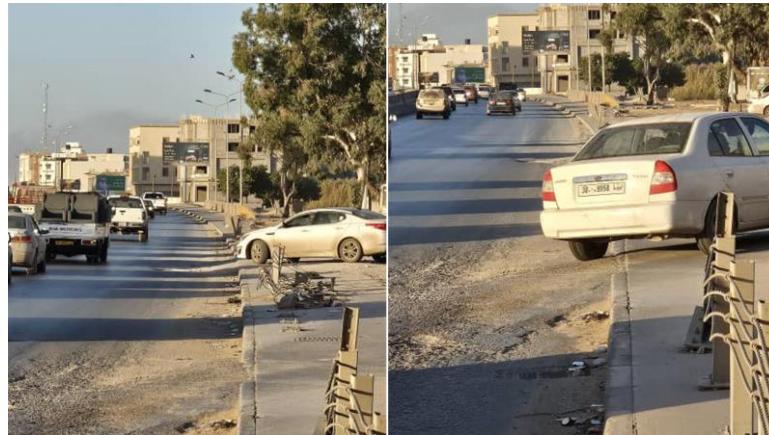
Figure (6): Improper Entry and Exit Maneuvers

Wrong-way entries and erratic exits cause confusion and panic among drivers, leading to unconsidered reactions and potential accidents. Additionally, exceeding the legal speed limit was widely observed, a primary cause of accidents in the city and country.

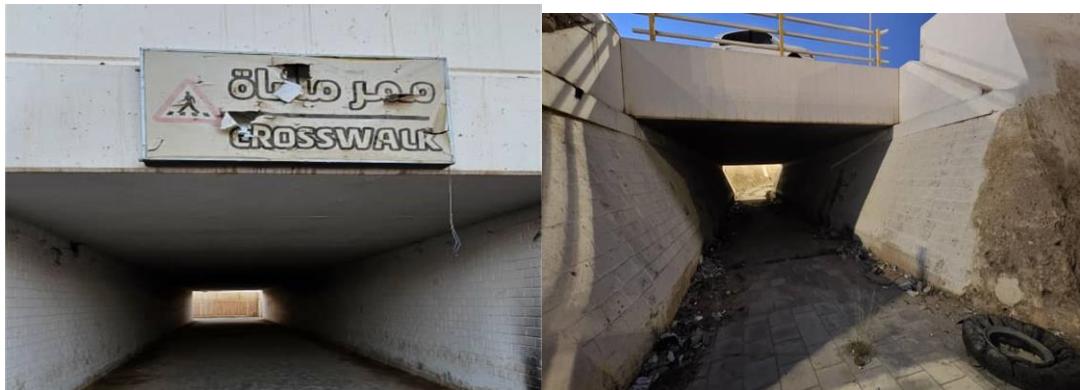
Figure (7): Neglected Pedestrian Subways

The pedestrian subways on the Third Ring Road suffer from severe neglect. They lack drainage, nighttime lighting, and regular cleaning. Walls, floors, and ceilings are damaged, with unpleasant odors and trash present. This neglect discourages their use, pushing pedestrians to cross the highway at grade, which is extremely dangerous.

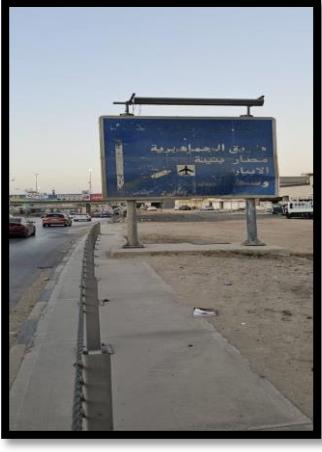
location	Safety concerns	Drawing/Picture	Risks	Recommendation
Highway entrance to Target Island	Text clarity: Difficulty in reading. Driver confusion: Overlapping information. Poor visibility: Weather affecting visibility. Outdated information: Outdated data poses risks. Lack of warnings: Insufficient information about hazards. Complex design: Difficulty in understanding. Overlapping signs: Overlapping signs lead to confusion. Neglected maintenance: Damage affecting effectiveness. Pedestrian safety: Lack of clear directions. Emergency response: Lack of necessary information.

law	<p>Suitable Location: Signs should be placed in prominent locations such as intersections and entrances, ensuring clear and unobstructed visibility.</p> <p>Design: Use an appropriate size for the location, bright and contrasting colors (e.g., blue background with white text), and simple, easy-to-read fonts such as Arial.</p> <p>Content: Clearly display the area name, provide clear directions (arrows), and indicate the remaining distance.</p> <p>Symbols and Images: Use easily understandable symbols and add images of landmarks if appropriate.</p> <p>Quality and Durability: Use weather-resistant materials and maintain them regularly to preserve clarity.</p> <p>Technology Integration: Include QR codes for additional information.</p> <p>Awareness: Organize campaigns to educate the public about the importance of signage.</p>

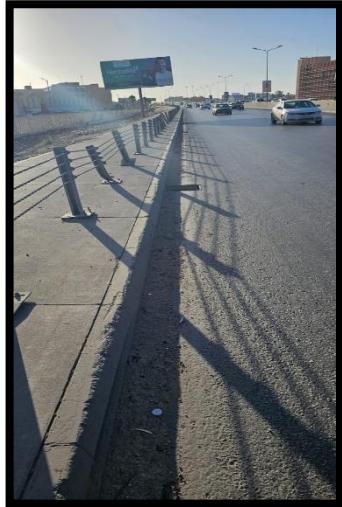
location	Safety concerns	Drawing/Picture	Risks	Recommendation
Arab Medical University Bridge Highway	<p>Material Selection: Use strong, weather-resistant materials.</p> <p>Design: The cover is designed to withstand the weight of vehicles and ensures proper drainage.</p> <p>Safety: Incorporate clear traffic signs and good lighting.</p> <p>Maintenance: Perform regular maintenance to address any damage quickly.</p> <p>Sustainability: Use environmentally friendly materials whenever possible.</p> <p>Cooperation: Collaborate with local authorities to ensure appropriate standards are met.</p>

HIGH	<p>Suitable Location: Signs should be placed in prominent locations such as intersections and entrances, ensuring clear and unobstructed visibility.</p> <p>Design: Use an appropriate size for the location, bright and contrasting colors (e.g., blue background with white text), and simple, easy-to-read fonts such as Arial.</p> <p>Content: Clearly display the area name, provide clear directions (arrows), and indicate the remaining distance.</p> <p>Symbols and Images: Use easily understandable symbols and add images of landmarks if appropriate.</p> <p>Quality and Durability: Use weather-resistant materials and maintain them regularly to preserve clarity.</p> <p>Technology Integration: Include QR codes for additional information.</p> <p>Awareness: Organize campaigns to educate the public about the importance of signage.</p>

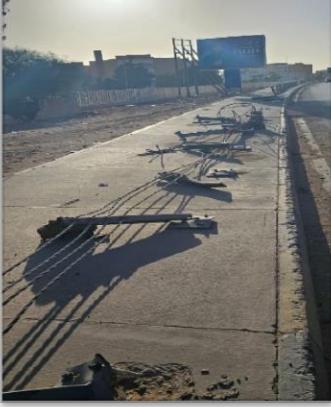
location	Safety concerns	Drawing/Picture	Risks	Recommendation
Highway barriers Iron side barriers	<p>Impact Resistance: May not withstand strong impacts.</p> <p>Corrosion: Exposure to elements that damage barriers.</p> <p>Improper Design: May not prevent skidding at high speeds.</p> <p>Location: Barriers in non-public areas may be ineffective.</p> <p>Lack of Visibility: May be invisible to drivers, increasing the risk of collisions.</p> <p>Impact on Traffic: May cause minor damage or traffic hazards.</p>

Medium	<p>Design and Durability: Barriers must be designed according to specific engineering standards to withstand the impact of large vehicles. High-quality stainless steel materials should be used, regardless of their durability.</p> <p>Location: Barriers should be installed at intersections where collisions are possible.</p> <p>Slopes: to prevent vehicles from skidding.</p> <p>Areas with high recovery capacity: such as highways and urban areas.</p> <p>General Maintenance: Conduct regular inspections, including checking for any mobile phones or other sounds, supervising and revising instructions to improve visibility, and replacing damaged or ineffective parts.</p> <p>Awareness Campaign: Install informational signs to educate drivers about the importance of barriers and organize workshops or community awareness campaigns to promote road safety.</p> <p>Materials and Coatings: Use weather-resistant materials such as anti-corrosive steel paint to protect against corrosion and a clear coating to ensure visibility at night or in adverse weather conditions.</p> <p>Implementation and Evaluation: Conduct periodic interventions to activate barriers and use data to analyze targets and identify areas needing improvement.</p>

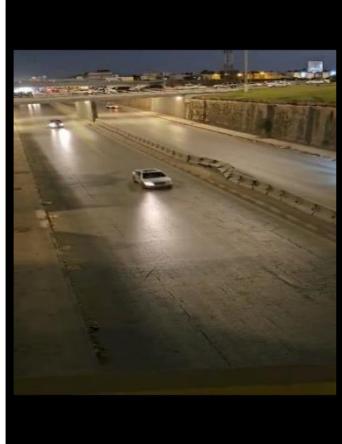
location	Safety concerns	Drawing/Picture	Risks	Recommendation
Highway tunnel median barriers	<p>Limited visibility: Barriers may obstruct drivers' view, increasing the likelihood of an accident and potentially leading to serious injury from a collision.</p> <p>Traffic congestion: Inadequate design can cause bottlenecks, affecting traffic flow.</p> <p>Pedestrian safety: Barriers may impede pedestrian crossing, increasing the risk of being struck by vehicles.</p> <p>Difficulty maneuvering: In emergencies, barriers may prevent traffic from changing speed.</p> <p>Weather effects: Conditions that may affect the effectiveness of barriers increase the risk of accidents</p>

Very high	<p>Appropriate Design: Barriers must be designed according to traffic safety standards, adhering to strict safety standards and ensuring adequate thickness to guarantee sufficient protection.</p> <p>Materials Used: High-quality concrete with proven durability and precision should be used.</p> <p>Location: Barriers should be placed in locations subject to physical force or where forces need to be separated.</p> <p>Comprehensive Regularity: Regular inspections of barriers should be conducted to ensure their integrity and prevent corrosion or damage.</p> <p>Lighting and Marking: Vehicle authorization should be achieved through the addition of lights or warning signs, subject to barrier control.</p> <p>All Additional: These measures can provide rapid intervention in collision situations.</p> <p>Integration with Neural Network: Barriers must be integrated with the lane design and the neural network's internal structure.</p>

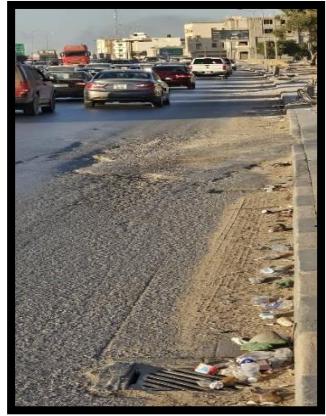
location	Safety concerns	Drawing/Picture	Risks	Recommendation
The highway after the mandatory diversion, Gulf Street	<p>Accident risks: Potholes and cracks can cause significant vehicle damage, increasing the likelihood of accidents.</p> <p>Road deterioration: These are defects.</p> <p>Ground instability: Large cracks may indicate underlying problems, such as soil erosion or a lack of overall support.</p> <p>Driver anxiety: Drivers may feel unsafe, affecting their concentration and ability to drive safely.</p> <p>Impact on traffic flow: Potholes can slow down traffic or close roads, causing delay</p>

high	<p>Periodic inspections: Conducting inspections of excavation sites.</p> <p>Rapid repairs: Implementing immediate repairs using high-quality materials.</p> <p>Design improvements: Redesigning roads using more durable materials.</p> <p>Awareness campaigns: Increasing drivers' awareness of the dangers of excavations.</p> <p>Cooperation: Urgent coordination between municipalities and the Ministry of Roads and Bridges.</p>

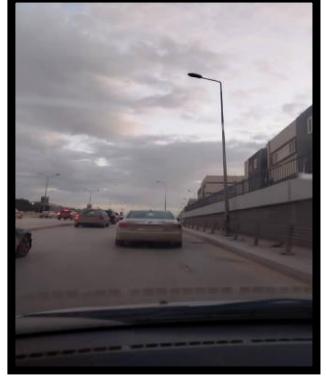
The highway is an entrance to Al-Khaleej Street in Al-Laithi.	<p>Public Safety: Improved nighttime visibility reduces traffic accidents and increases pedestrian safety.</p> <p>Security: Lighting helps reduce crime and provides a sense of security for residents and passersby.</p> <p>Improved Quality of Life: It contributes to making the area more attractive for commuting and social gatherings.</p> <p>Area Development: Good lighting can encourage investment and development in the surrounding areas.</p>

medium	<p>Increased Accidents: Poor lighting can lead to an increase in traffic accidents, especially at night.</p> <p>Crime: Dark areas encourage crime, such as theft and assault.</p> <p>Pedestrian Safety: Insufficient lighting threatens the safety of pedestrians and cyclists, increasing the risk of collisions.</p> <p>Difficulty Seeing Traffic Signs: Inadequate lighting makes it difficult to see traffic signs and signals, leading to driver confusion.</p> <p>Psychological Impact: Feeling unsafe in dark areas can negatively affect traffic flow and road use</p>

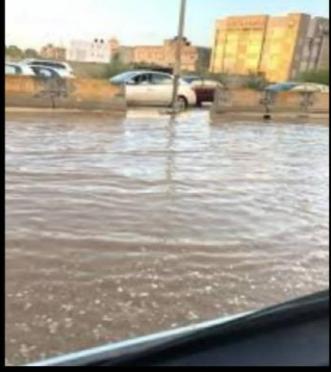
location	Safety concerns	Drawing/Picture	Risks	Recommendation
Rainwater accumulates on the Third Ring Road	<p>Vehicle skidding: Increases the risk of accidents</p> <p>Limited visibility: Affects drivers' visibility</p> <p>Traffic obstruction: May lead to traffic jams</p> <p>Mechanical malfunctions: Cause problems in vehicles</p> <p>Infrastructure deterioration: Affects road quality</p> <p>Pedestrian safety: Poses a risk to pedestrians</p>

High	<p>Traffic warnings: Place warning signs along the road to alert drivers to water accumulation.</p> <p>Identifying hazardous areas: Conduct studies to identify locations most prone to water accumulation and place clear signage in these areas.</p> <p>Improving drainage: Ensuring that drainage systems are in good working order to minimize water accumulation.</p> <p>Reducing speed: Reducing the speed limit in areas prone to water accumulation.</p> <p>Awareness campaigns: Disseminating information to drivers on how to handle wet road conditions.</p> <p>Regular maintenance: Conducting regular road maintenance to ensure there are no obstructions that could lead to water accumulation.</p>
