المؤتمر العلمي الدولي الثالث للعلوم والهندسة

The 3rd Scientific International Conference in Science & Engineering

Determining the value of the pavement condition index for some traffic intersections using a Paver program.

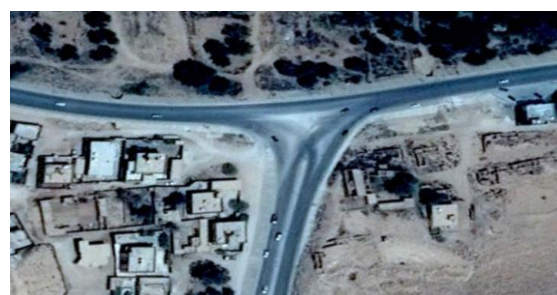
Fig. 2: Abusedra Intersection

A single-level, three-legged, dual-directional intersection with two lanes in each direction, and the direction (north-south) is separated by a central island extending along the road between the intersection and the turning island at its end. Figure (2) shows the intersection.

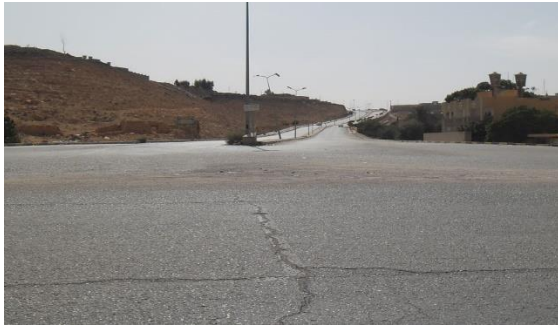
Fig. 2: Damages in the intersection

The process of observing and measuring the severity and density of the defects was carried out after determining the number of samples and the type, severity and density of the defect in each of them, as shown in Table No. (2), in preparation for starting to enter them into the (Paver) program. Figure (3) shows some damages at the intersection.

After the field visits and visual inspection, there were some damages in the intersection’s pavement layers. The number of samples was determined and the severity and density of the defects and their percentage of the sample area were recorded. The Paver program was used, and after entering the data into the program, it calculated the paving service index and it was 71, which expresses the condition of the area. Good for the intersection surface with the need for some simple maintenance work or what is called (Corrective maintenance).

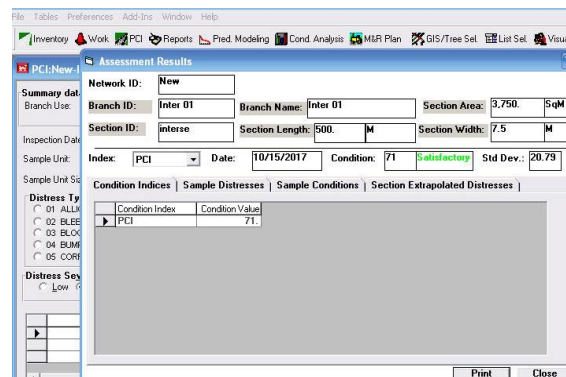
Fig. 4: PCI calculation

After entering all the samples, the program calculates the pavement condition index, as shown in Figure No (5).

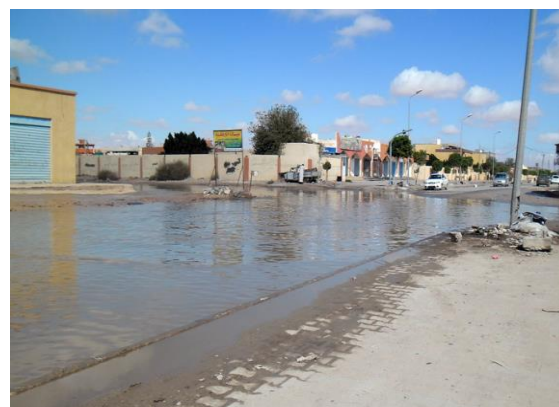
Fig. 6: The location of the current indicator on the PCI curve.

Water leaks into the intersection due to cracks in the asphalt surface, which over the past years has caused almost complete damage to the intersection’s surface, as rainwater accumulates greatly as a result of the lack of a drainage system inside the intersection and the roads adjacent to it, and the intersection cracks for various reasons, the most important of which may be poor implementation and failure to adhere to the appropriate levels for raising the road body. Figure (6) shows rainwater collecting inside the intersection, which remains for long periods

From a structural standpoint, the second intersection suffers from major problems affecting the traffic movement inside, as rainwater accumulates greatly inside the intersection, which negatively affected the condition of the paving. After studying the constructional condition of the intersection through the (Paver) program, it became clear that the service index is 19, and this indicates that the intersection needs complete rebuilding and maintenance.

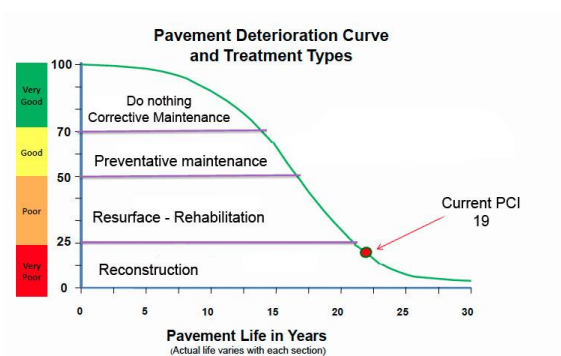
Fig. 10: The location of the current indicator on the PCI curve.

By using the same previous steps, the condition of the intersection was very bad, as the asphalt condition indicator was (8), and according to what the location of the indicator appears on the curve in Figure (10), the intersection needs to be reconstructed again.
