### Effect of Carbonation on Existing Reinforced Concrete Building

This paper presents the results of the field and an experimental investigation of the accommodation building at the National Cancer Institute in Sabratha. Site inspection and destructive tests were conducted including the effect of carbonation diffusion. The results showed the depth of carbonation exceeds the location of steel bars in most element structures. It is also indicated that the compression strength of concrete decreases with the depth of carbonation increase. However, the density of concrete increases with a carbonation depth increase. Evaluation of the building is necessary and important due to the advanced age of the existing structure. This evaluation leads to either rehabilitation or removal as a result of the spread of corrosion in most of the structural elements of the building.

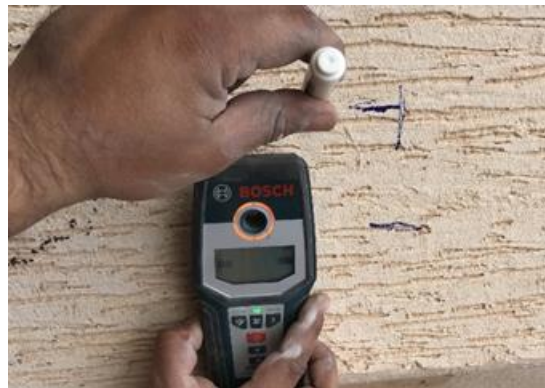
A survey of concrete surfaces was conducted with a micro cover meter surface sensor per British specifications (BS 1881: Part 204:1988) [6]. The survey aims to determine the locations of the reinforcing bars in preparation for extracting the cut concrete samples (concrete cores). In addition, to measure the concrete

cover. The value of the concrete cover ranged from 10 to 25 mm, and Figure (15) shows the use of the device.

**Fig. (15):** Using a cover meter to indicate the location of reinforcement before taking core

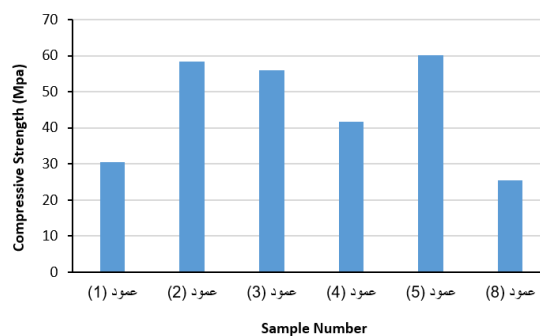
The obtained results of the compressive strengths of concrete specimens are presented in Table 2 and Figure 20. In addition, it shows the concrete density of the tested samples. The range of compressive strength is 37 MPa to 60 MPa and the average is 49 MPa. The strength of concrete is considered acceptable for this type of concrete structure after approximately 42 years from the date of its construction.

**Fig. (20):** Compressive strength of tested samples
