**Cracks in the walls around the windows and doors openings
(CASE STUDY)**

Dr. naji amhimmid salih
Civil Engineering Department-Faculty of Engineering – Bain- Walid University
Najisalah320@gmail.com

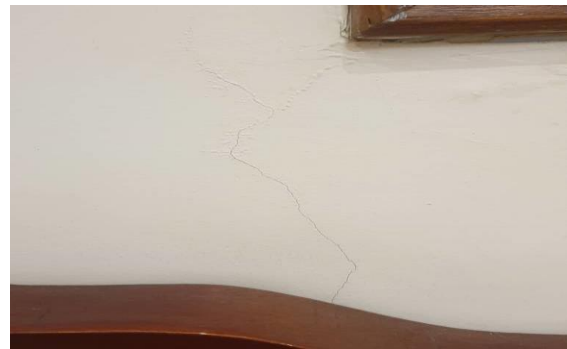
Fig. 1: shows cracks at the bottom of the window

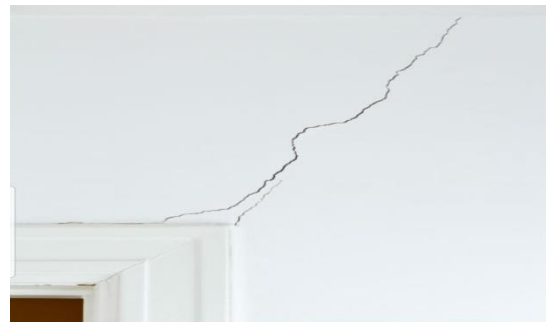
Fig. 2: shows the cracks at the top of the window

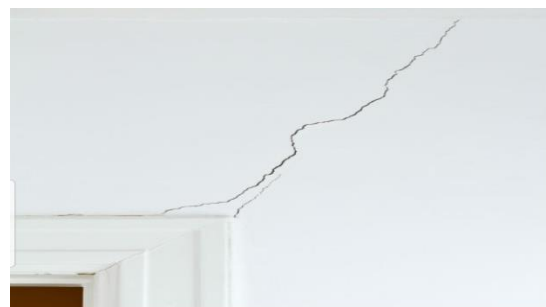
Fig. 3: shows the cracks at the top of the window

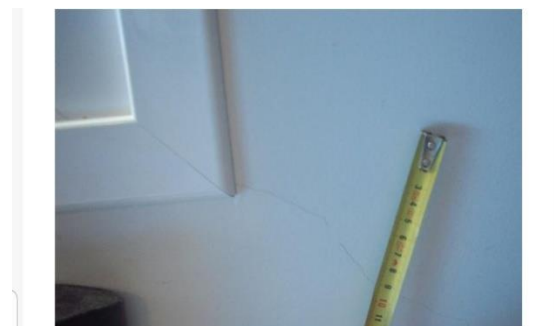
Fig. 4: shows cracks at the bottom of the window
